BioWorld Products

Winery Irrigation Reservoir Case Study

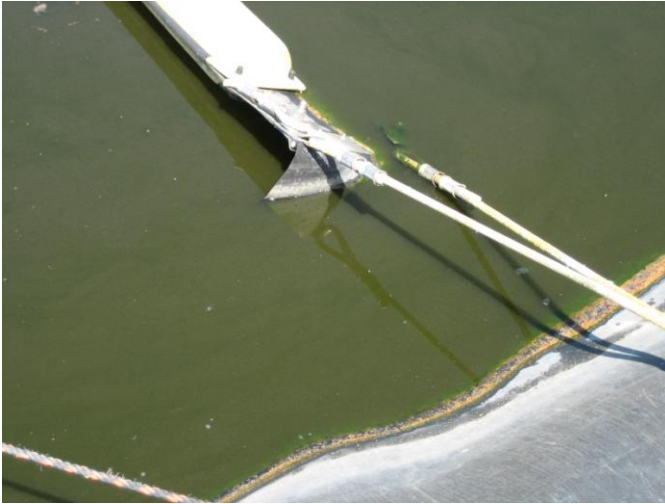
A Napa Valley winery had a ½ acre irrigation reservoir with planktonic, single cell, green water algae. Chemical treatments including ammonia were done in the past but the algae continued to be a problem. Total Suspended Solids (TSS) and Biochemical Oxygen Demand (BOD) measurements were averaging 300 mg/l and 40 mg/l, respectively. Dead algae and solids also built up on the reservoir bottom.

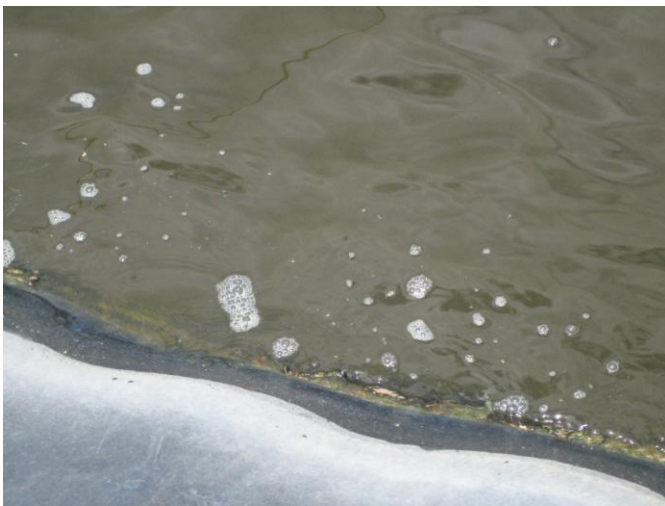
BioWorld Green Water Algae Treatment products were applied each week. After 6 - 8 weeks, the algae were significantly reduced and average TSS and BOD measurements were 75 mg/l and 20 mg/l, respectively. This corresponds to a 75% TSS reduction and a 50% BOD reduction. Over time, solids broke loose from the bottom and were digested. On-going treatments have continued to balance the ecosystem for the long term with environmentally safe and natural products.

BioWorld Products used:
35064 Liquid Optimizer
33086 Green Water Algae Microbes
36086 General Blend Microbes
