# Advanced BioTech

## Oil/Water Separator Bioremediation Case Study

Waste oil was about 3 inches thick in a 600 gallon oil/water separator at a tractor repair facility.

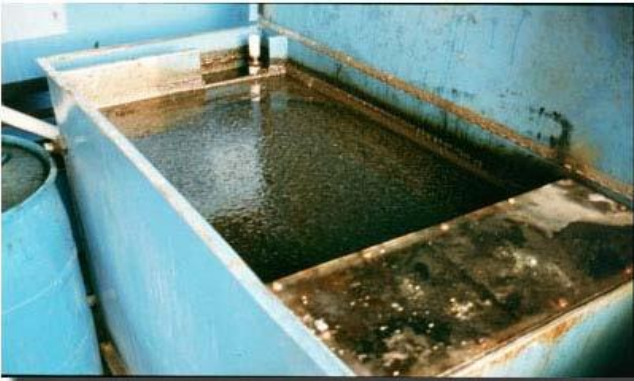
3 days after BioWorld Hydrocarbon Treatment, the thick oil was degraded to a fine layer of fatty acids. (The unit was moved outside.)

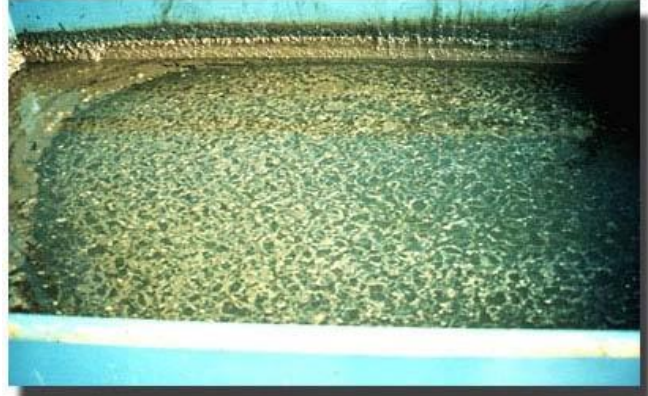
3 days after BioWorld Hydrocarbon Treatment, the oil was degraded for safe disposal as non-hazardous material.

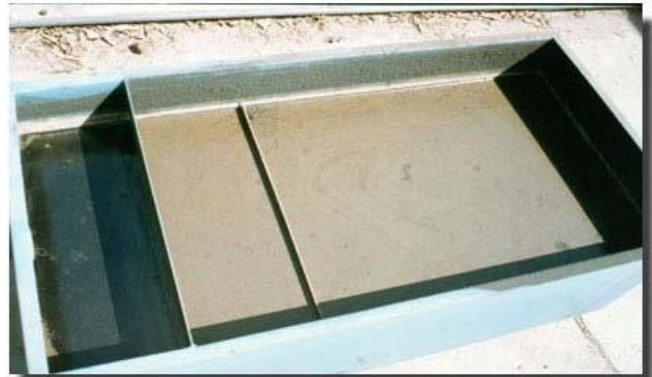
Oil was about 1 inch thick after treating with BioWorld Hydrocarbon treatment products. The tank was rolled outside.
